MOUSAM RIVER BASIN  
SHAPLEIGH, MAINE

EMERY MILLS DAM  
ME-00186

PHASE I INSPECTION REPORT  
NATIONAL DAM INSPECTION PROGRAM

OCTOBER 1978

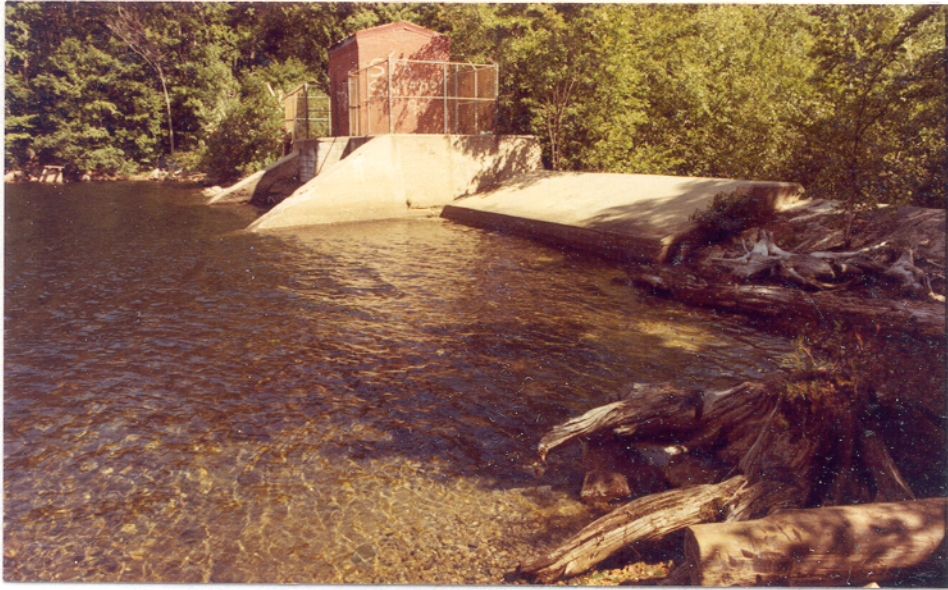
1

parent. The spillway section of the dam consists of a stone masonry portion and a concrete portion. Both sections show no signs of erosion and are in good condition. See photograph 1.

UPSTREAM VIEW OF DAM

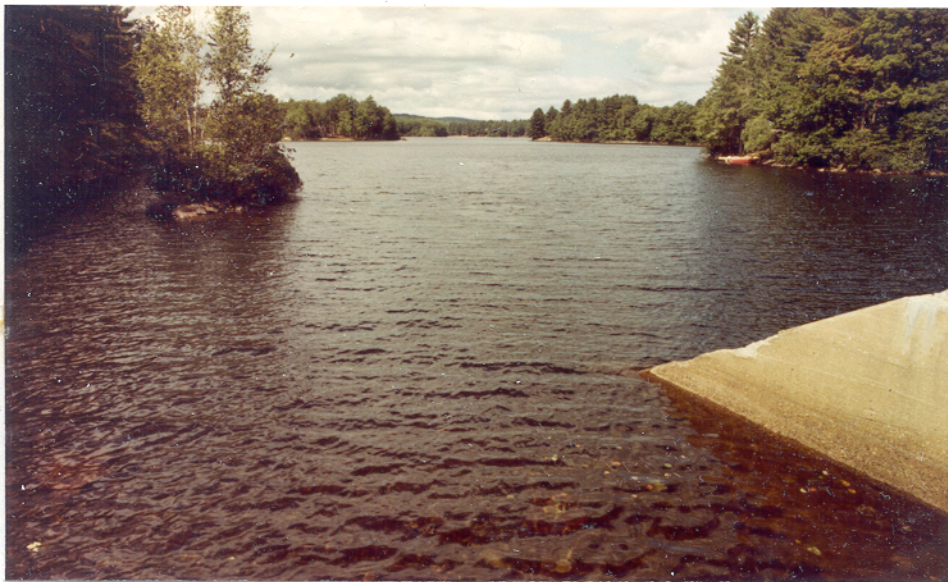
2

VIEW OF MOUSAM LAKE FROM DAM

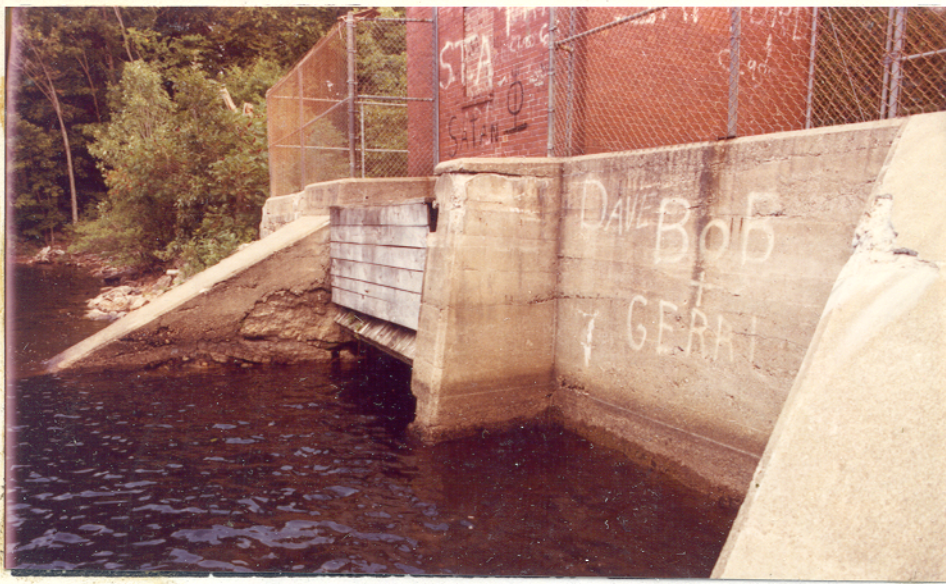
3

- (a) The dam structure appears to be true to line and grade; no horizontal or vertical movement was observed.
  - (b) Some spalling of the concrete surfaces in the areas of the controlled outlet gatehouse has occurred. See photograph 3.

- a. Inlet Structure - the inlet structure consists of concrete wing walls which form a channel to the outlet gates. A trash screen consisting of steel grating is upstream of the gates. An accumulation of debris was observed on the trash screen. The location of the screen is such that it would be very difficult to remove debris from its surface.

CONTROL GATE INTAKE STRUCTURE

5. Repair areas of spalled concrete.
  6. Provide around-the-clock surveillance during periods of anticipated high runoff.
  7. Develop a formal warning system and implement its use in the event of an emergency.

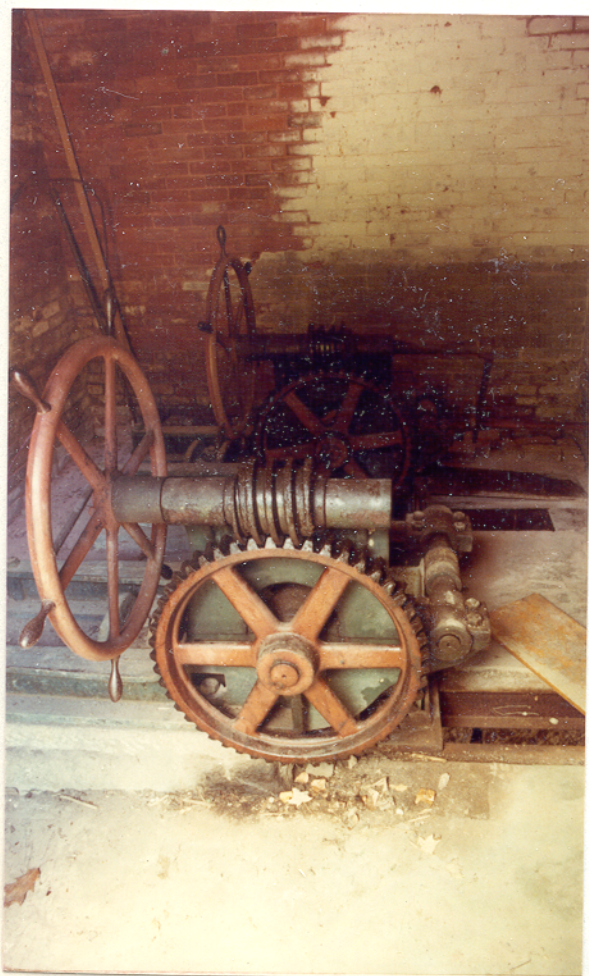
4

- b. Operating and Emergency Control Gates - the gates are raised by means of a vertical rack and gear. The gate stems, one for each gate, consist of steel beams. These beams appear to be in good condition; very little corrosion has occurred. The gate operating equipment was found to be in good repair. See photograph 4. The gates were operated during the inspection and it was observed that they operated properly.

CONTROL GATE MECHANISM

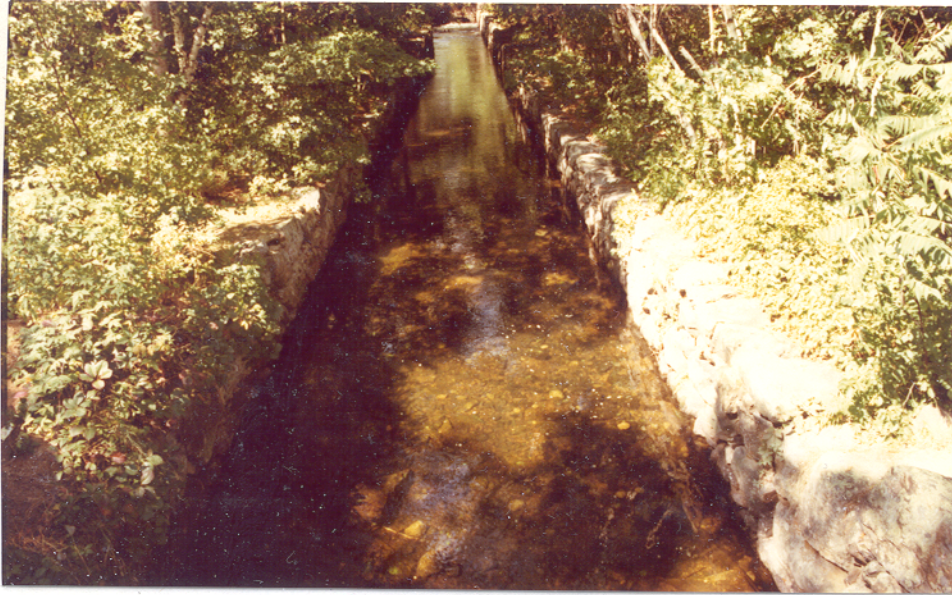
5

VIEW OF DISCHARGE CHANNEL LOOKING UPSTREAM AT DAM

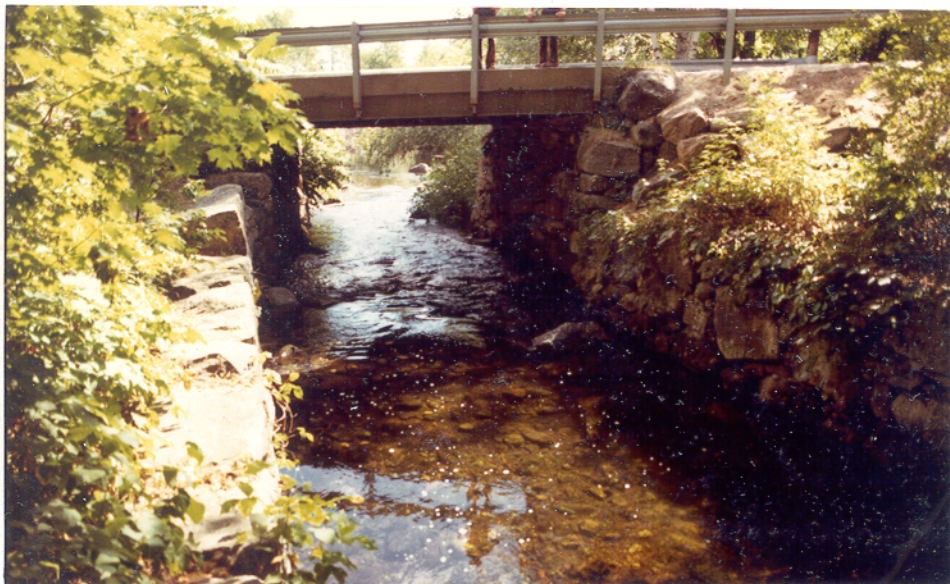
6

BRIDGE 250 FEET DOWNSTREAM OF DAM
